## BNF Consulting, Inc.

## Mold Inspection Report

Property Address:

Inspected on Mon, Aug 9 2021 at 11:30 AM

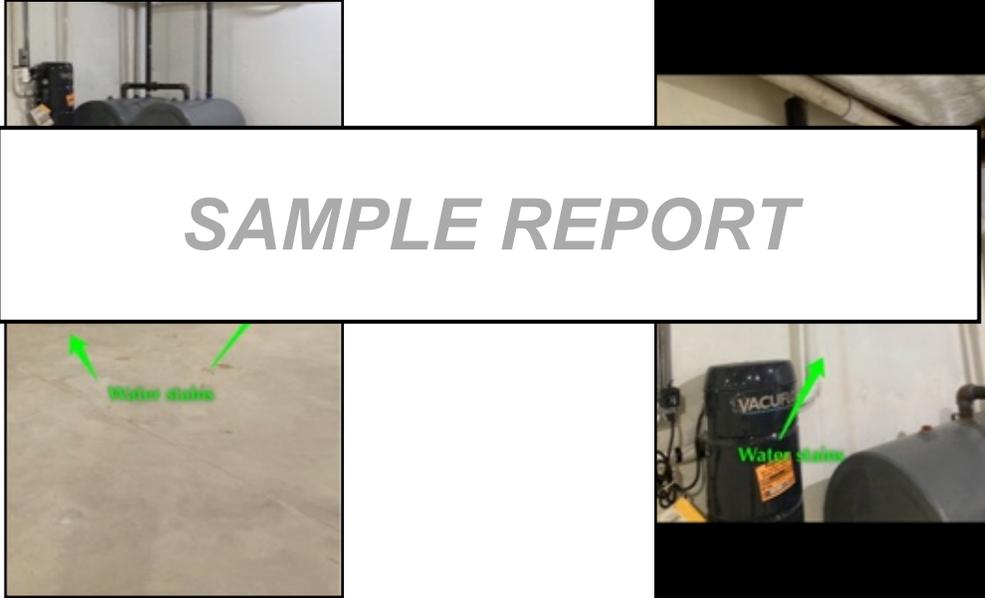
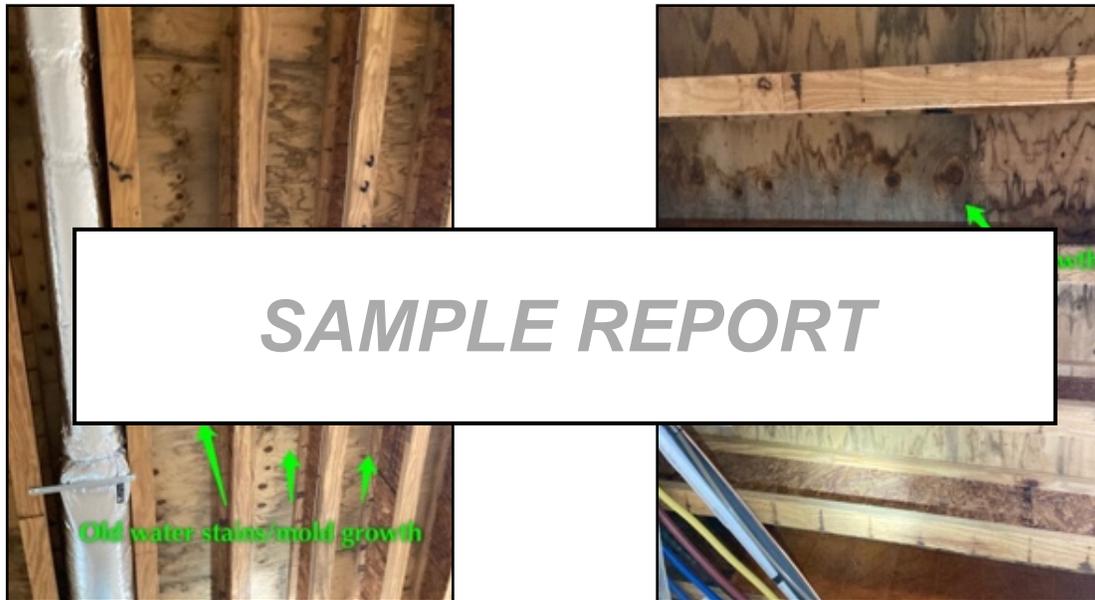
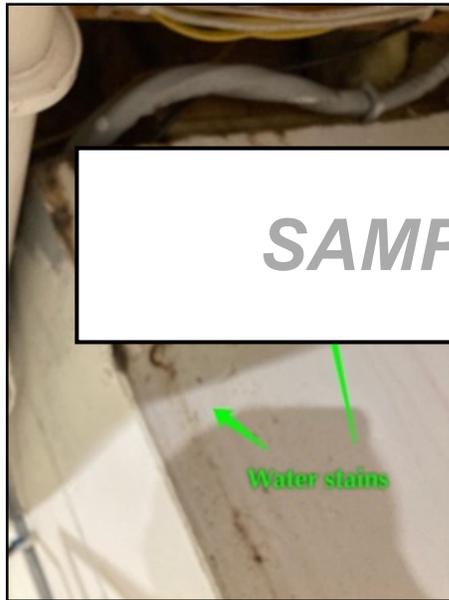
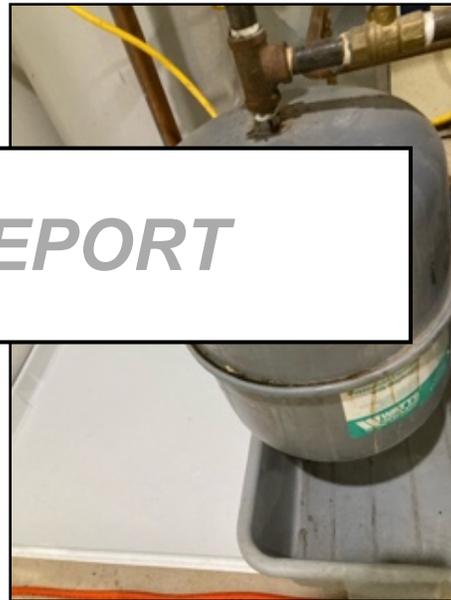
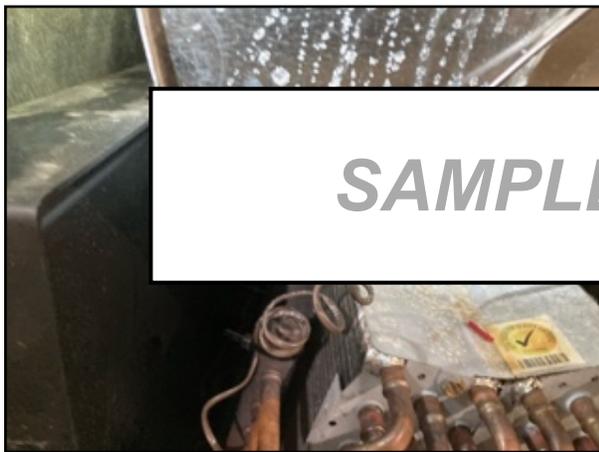
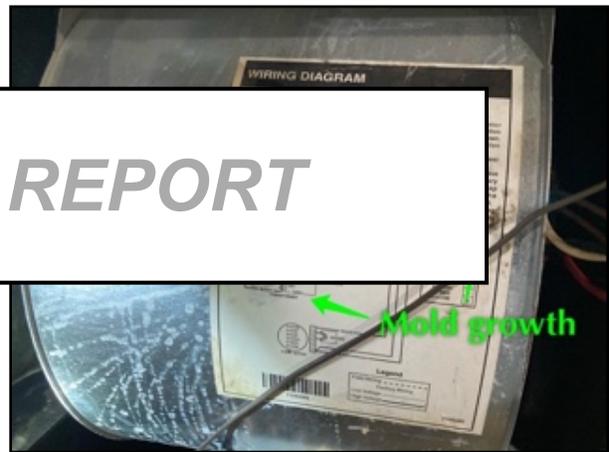
Location #1: Basement

1. Upon examination of the basement , BNF Consulting observed an elevated relative humidity of 61% RH. Ideally, RH should be maintained at 30-50% to prevent ample conditions for mold growth. It is recommended to run commercial-sized dehumidifiers to maintain proper humidity levels.

2. Additionally, water stains and visible mold was seen throughout the basement's ceiling or the subfloor plywood throughout the entire basement ceiling. Prior plumbing issues may have been saturated the ceiling and may not have been properly remediated/dried.

3. Water stains on the basement slab foundation floor and walls due to water leaks from the air handler unit, the boiler, and water heater. Learned that water puddles were on the floor few days ago. This could have contributed to high humidity in the basement to lead mold growth as well.

- A. The expansion tank connected to the boiler shown water drip stains. It may has been leaking in the past.
  - B. The air handler unit also has visible water drip stains on the unit.

- C. Noted drip pan under the flush outlet to the water heat. Suspected water leak in the past.
4. The air handler unit has also shown visible mold growth on the interior parts.

It is recommended to remove or properly remediate mold in the air handler unit or

replace the unit. Hire a qualified contractor and perform HEPA sandwich cleaning (HEPA vacuum, anti-microbial wipe, HEPA vacuum) throughout the entire ceiling and walls with encapsulation.

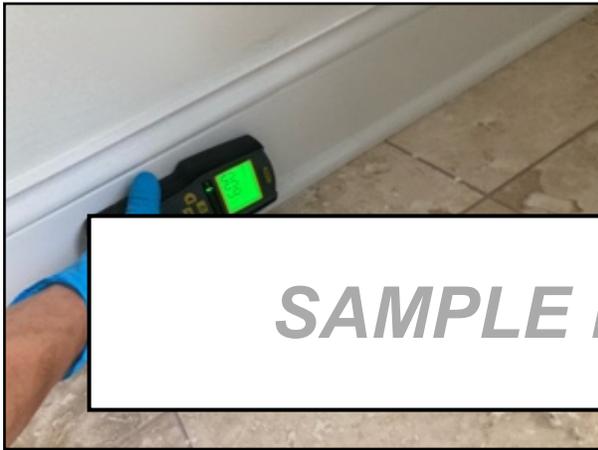
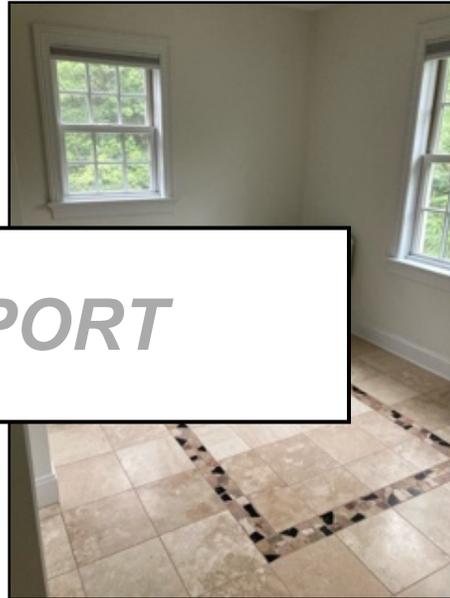
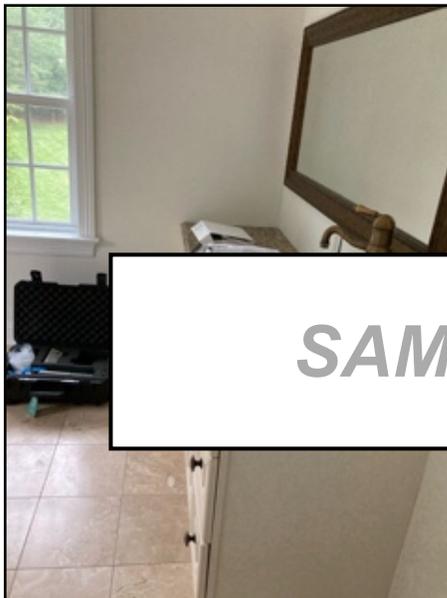
Location #2: 2nd floor bathroom

Due to prior plumbing issues causing a water leak, a moisture reading was done through the second floor bathroom walls. Upon examination of the second floor bathroom, no elevated moisture was detected and normal spore count was sampled in the area.

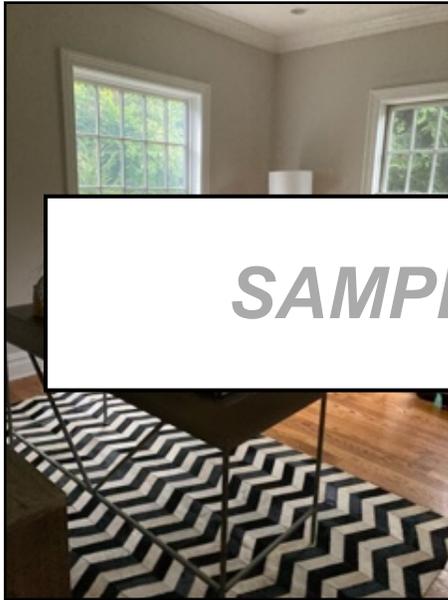
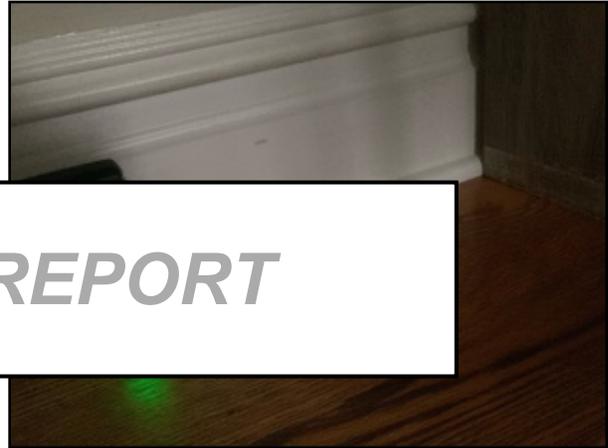
Location #3: 1st Floor Office

Due to prior plumbing issues in the bathroom on top of the office causing a water leak, a moisture reading was done. Upon examination of the office no elevated moisture was detected and normal spore count was sampled in the area.

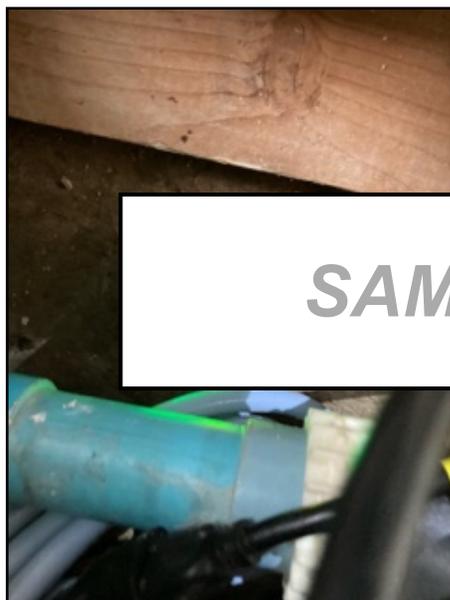
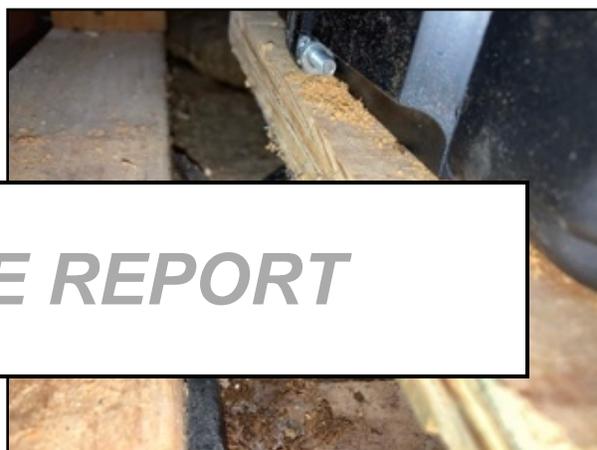
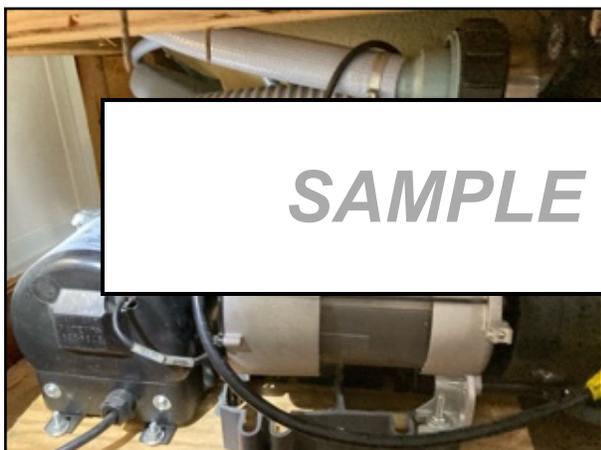
Location #4: Master bathroom

Upon examination of the master bathroom, BNF Consulting observed elevated moisture beneath the jacuzzi/bathtub. Samples were taken due to potential cross contamination and it indicated a normal mold level.

However, it is recommended to remove the system (pump, hose, etc) beneath the jacuzzi/bathtub to discard the wood board under the pump while it had elevated moisture on it. Perform HEPA sandwich cleaning in the bathtub cavity and dry out.

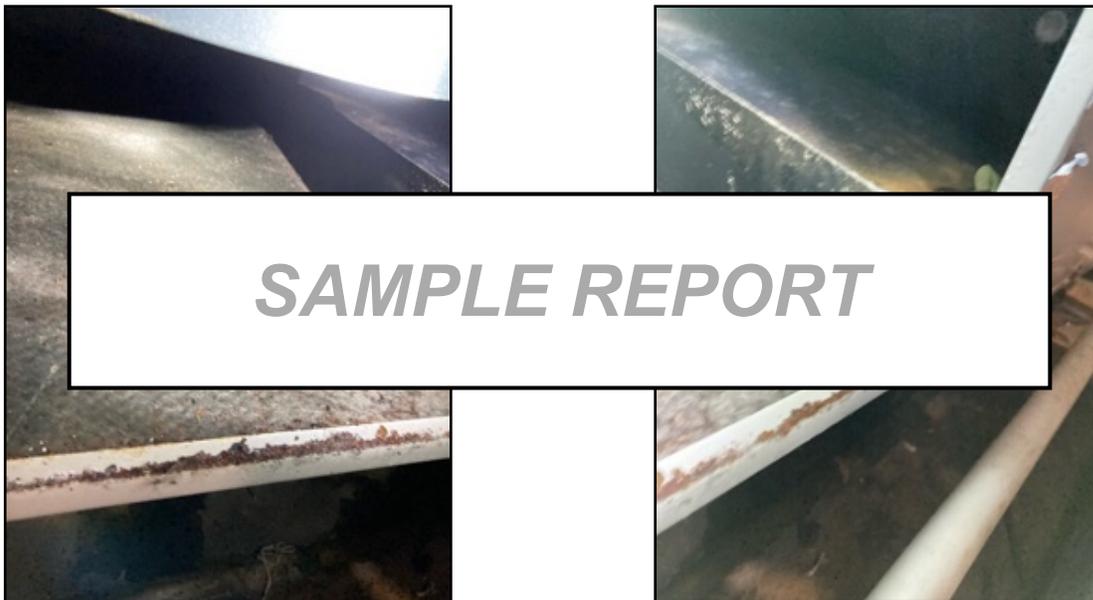
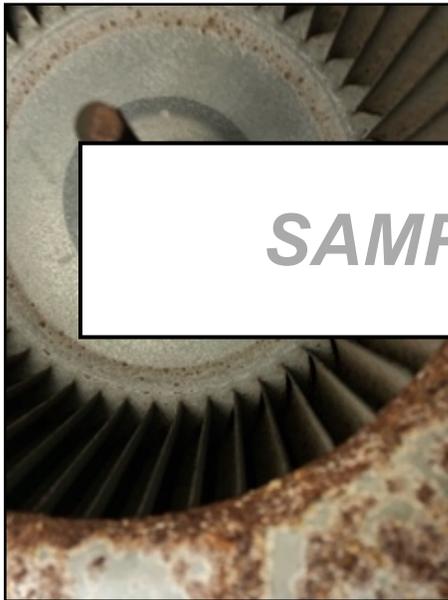
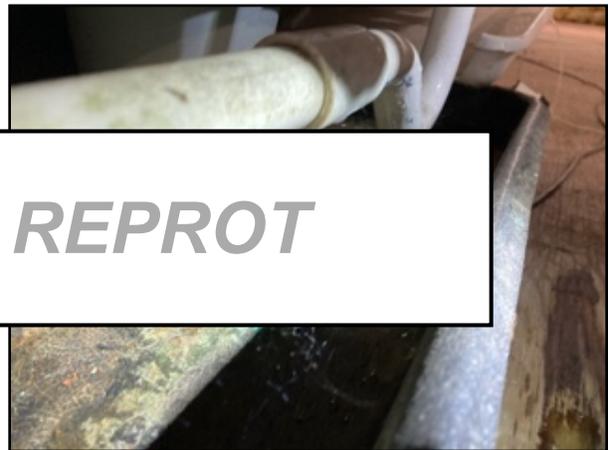
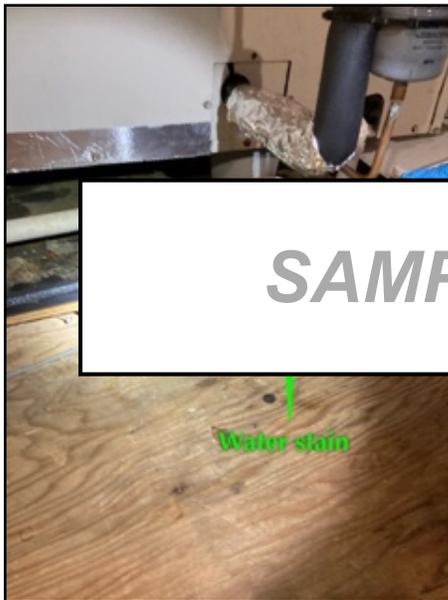
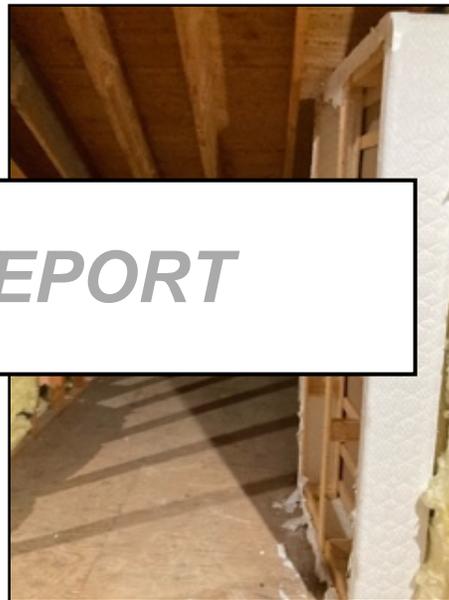
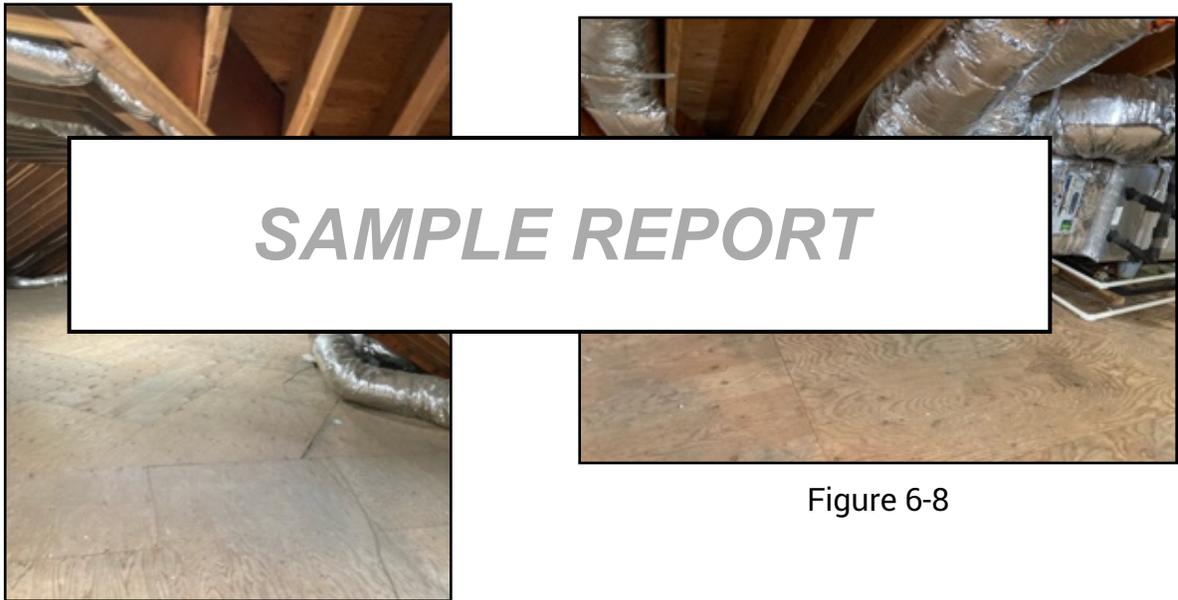
Location #5: Attic

1. Upon examination of the attic, multiple spots of visible mold growth were found on the studs and rafters.
2. The air handler unit has also shown visible mold growth on the interior parts.

It is recommended to remediate the mold on the spots on the rafters and studs in the attic. Hire a qualified contractor and perform HEPA sandwich cleaning (HEPA vacuum, anti-microbial wipe, HEPA vacuum) only spots where visible mold present.
