LEAD RISK ASSESSMENT REPORT

David Jones ABC Street New York, NY 10590

Date of Assessment: June 5, 2020

Completed By: Justin Joe, PhD, CIH, CSP, CBCP BNF Consulting, Inc. 152 Route 202, #404 LincoIndale, NY 10540 Justin@askbnf.com

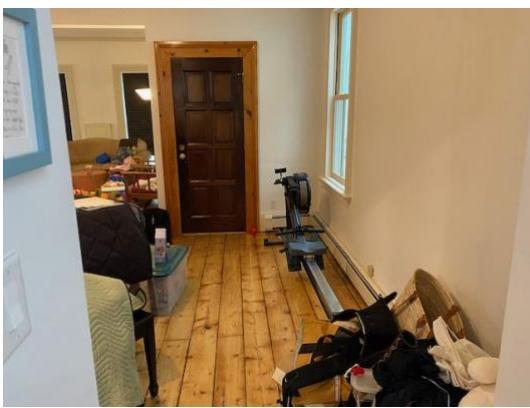
Figure (4) – Front Entrance

Sample Number	Location	Results
Wipe #02	1st FI Entrance	12.6 μg/ft²

- 06-01-2020 Recommend to remediate lead paint dusts in the living space using <u>General Lead Remediation / Restoration Plan</u> described above in the Section 6.0 for the following areas:
 - 1st floor entrance between the living room and the kitchen
 - 2nd floor master bed and the playroom next to the master bedroom
 - Rear staircase from the 2nd to 3rd floor
 - Staircase to the basement and landing at the bottom area
- 06-02-2020 Recommend to remediate lead dust on personal belongings with the following procedures.

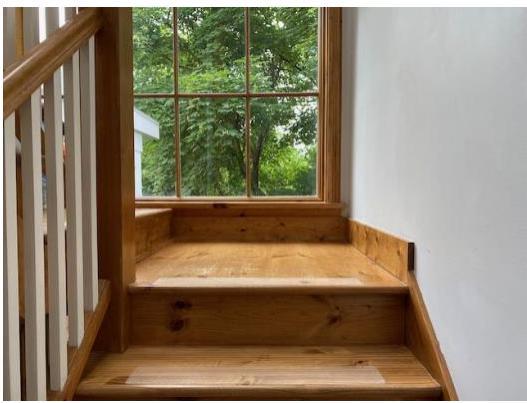
Figure (5) – Staircase landing to 3rd floor Figure (6) – Baby's room

Wipe #07	2nd FI Master Bed	35.6 μg/ft²
Wipe #08	2nd/3rd FI Staircase Landing	38.8 μg/ft²
Wipe #11	Basement Staircase Landing	45.6 µg/ft²

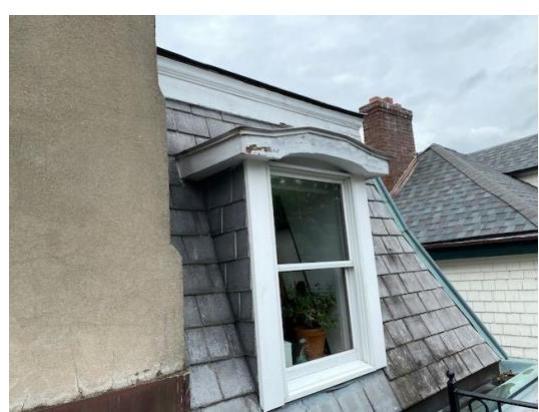
Figure (11) – Dommer window frame

Sample Number	Location	Result
Paint Chip #01	Ext. Dormer Trim 3rd Fl	<0.009% By Weight

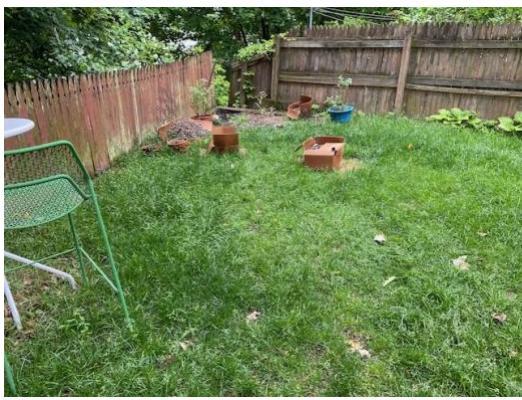
Figure (13) – Backyard

Sample Number	Location	Results	
Soil #01	Front	774.8 μg/g	
Soil #02	Front	697.6 µg/g	
Soil #03	Rear	767.9 μg/g	
Soil #04	Rear	773.7 μg/g

- 1. Replacement: 1-foot deep topsoil in the contaminated area can be removed and replaced with uncontaminated soil.
- 2. Enclosure: Provide a barrier between the contaminated soil and children by covering the contaminated bare surfaces with concrete or pavement.

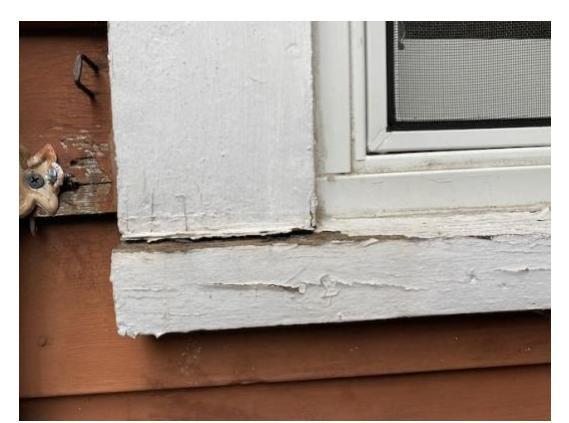
Figure (15) – Exterior window rear

Sample Number	Location	Results
Paint Chip #02	L/R Window Trim #1	2.604% By Weight
Paint Chip #03	L/R Window Trim #2	2.696% By Weight
Paint Chip #04	Exterior Wall Window #1 Front	1.161% By Weight
Paint Chip #05	Exterior Wall Window #2 Rear	0.571% By Weight

- If you need to confirm surface cleaning effectiveness for decontamination of non-porous or semi-porous materials, collect surface samples using tape, swabs, or wipes.
- 2. Surface sampling results should be at background levels.
- 06-03-2020 Recommend to abate lead-based paint in the exterior and interior surfaces using Lead Abatement Methods described above in the Section 6.0 for the following areas:
 - 1st floor living room window trims
 - Exterior walls including windows
- 06-03-2020 Recommend to abate lead in soil near play areas and high-contact areas for children using Lead Abatement Methods described above in Section 6.0 for the following areas including flower garden in the front and backyard ground.
