## Mold Survey Report

**ABC Street**

**New York, NY 10591**

Inspected on Thu, Oct 1 2020 at 5:00 PM

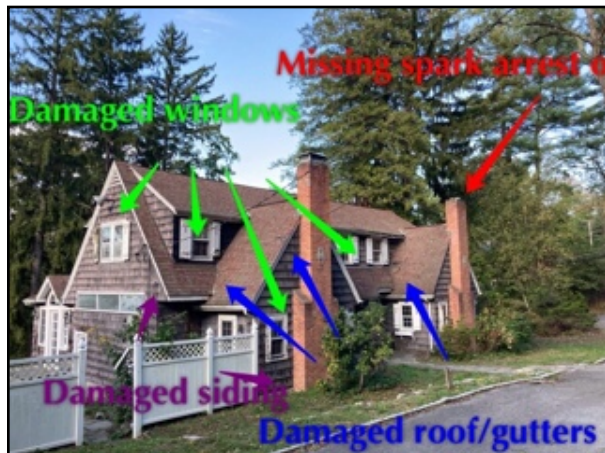
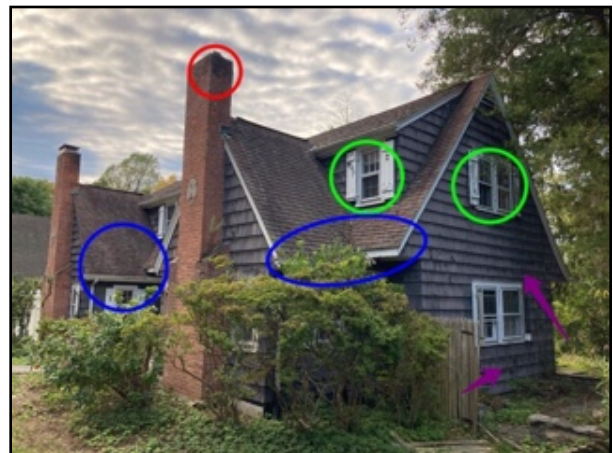
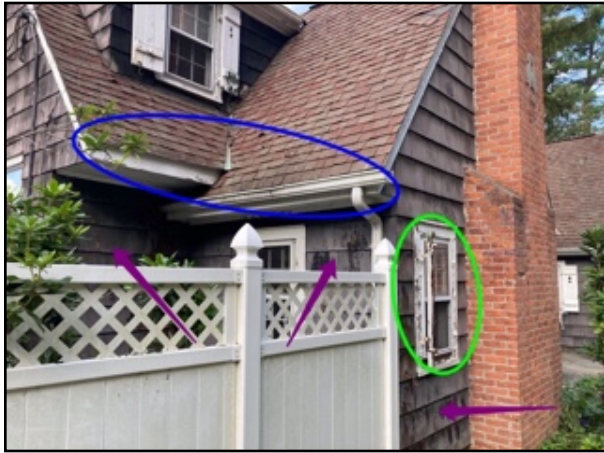
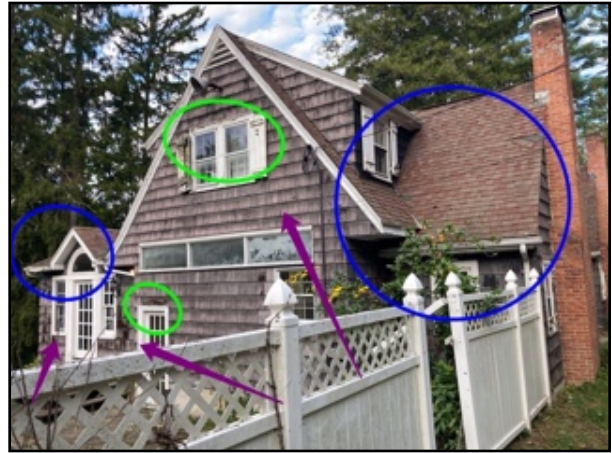
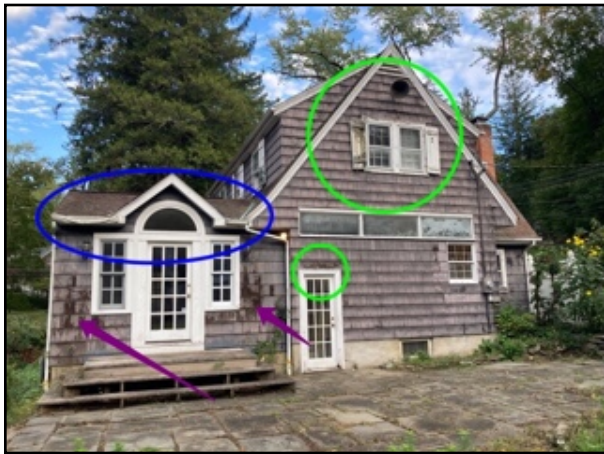
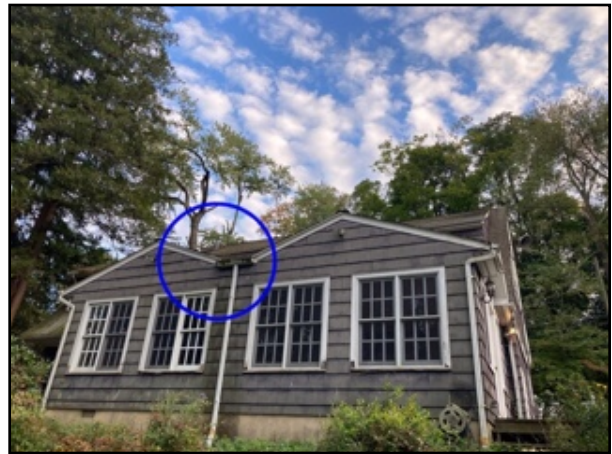
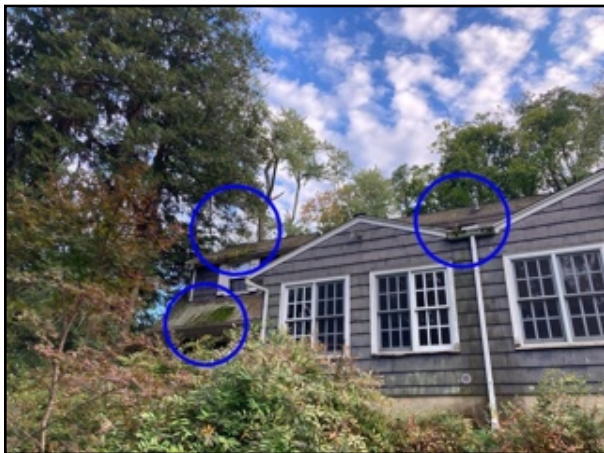
A walkthrough of the home was preformed visually with a inferred camera and a moisture meter on all levels including the unfinished attic, unfinished basement and crawlspace. The purpose of the survey was two folds 1) to evaluate the potential exposure to mold and 2) to provide a remediation plan accordingly. Multiple spore trap air samples and tape lift samples were taken to identify and quantify mold types in the property. Assisting during the survey was the buyers realtor.

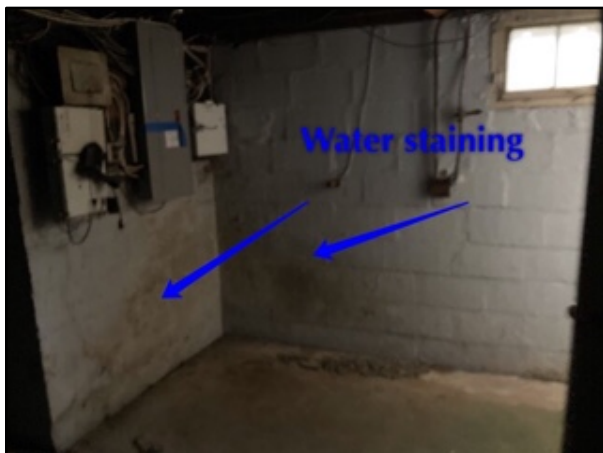
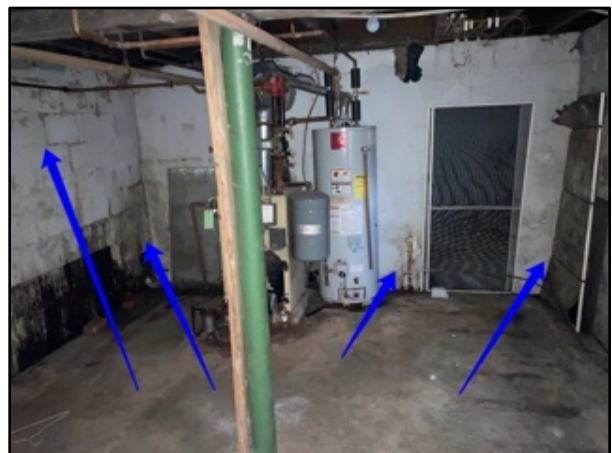
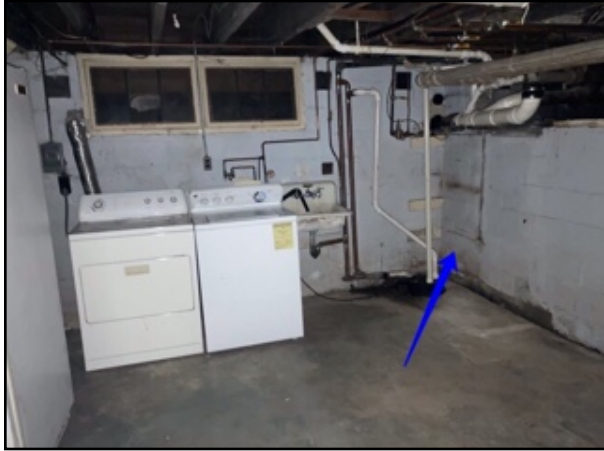
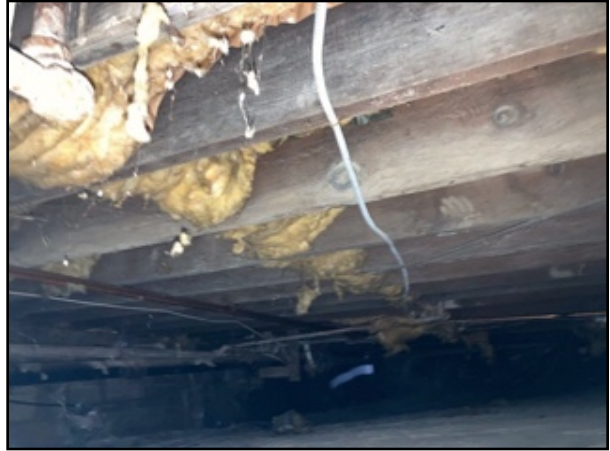
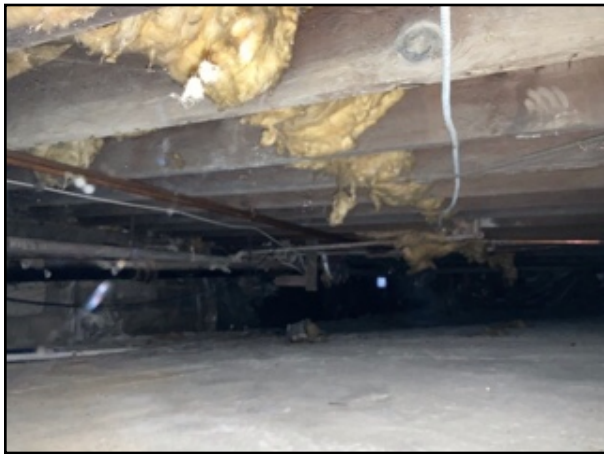
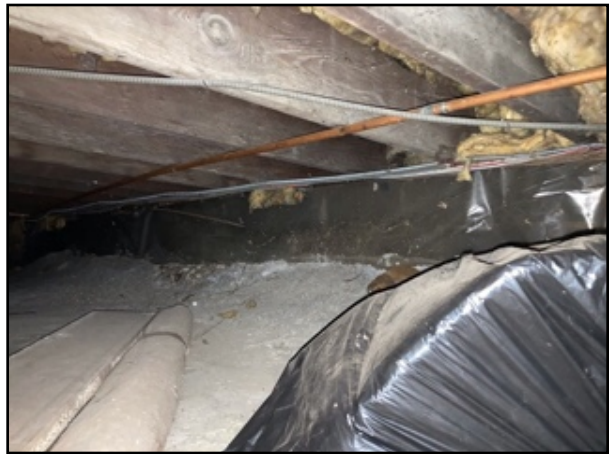
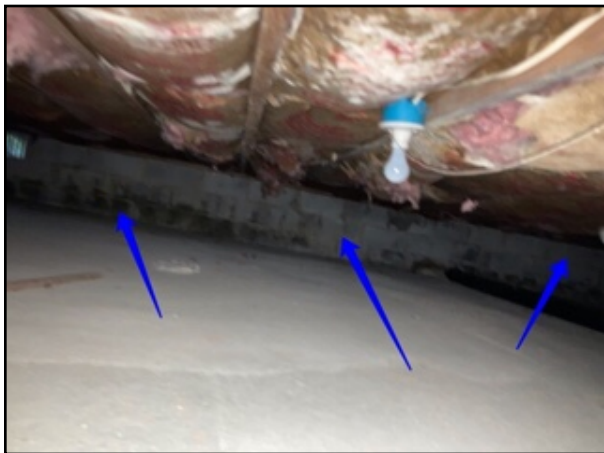
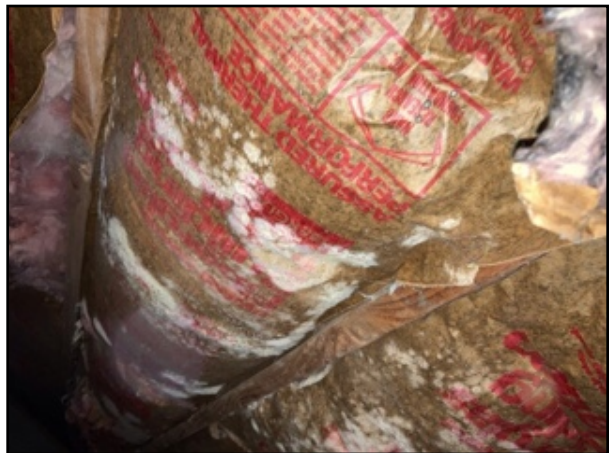
Upon inspection a visual inspection concluded that a mold like substance was visible. Some moisture was found visually on the lower portion of the concrete block walls as well as visual mold on the ceiling joist and exposed insulation. Since basement is below grade high humidity is common in these areas and could cause poor air quality/heightened mold spores especially during the summer damp months. A French drain and sump pump are located in the basement but they do not seem to be working. 1 Air Sample and 2 swabs were taken for mold contamination. Recommend 1) Install/maintain a dehumidifier to control humidity 2) Confirm sump pumps and French drain are in working order and 3) Remediation in the affected area as described in the following Remediation Section.

A. Unfinished Basement/Crawlspace

- Remove all exposed insulation. Follow cleaning guidelines stated below

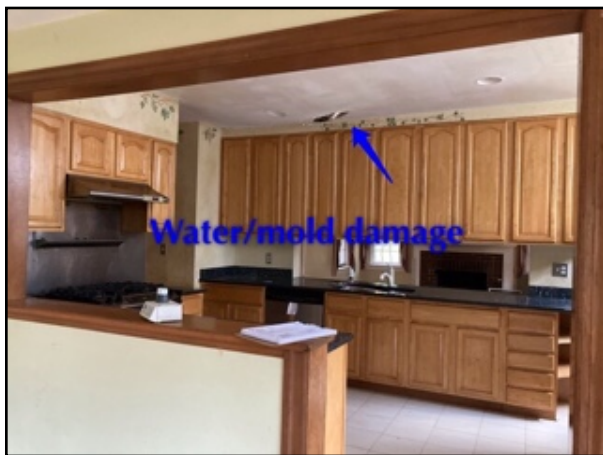
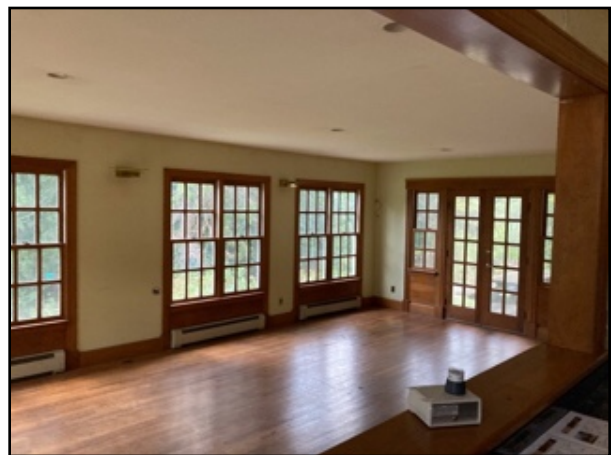
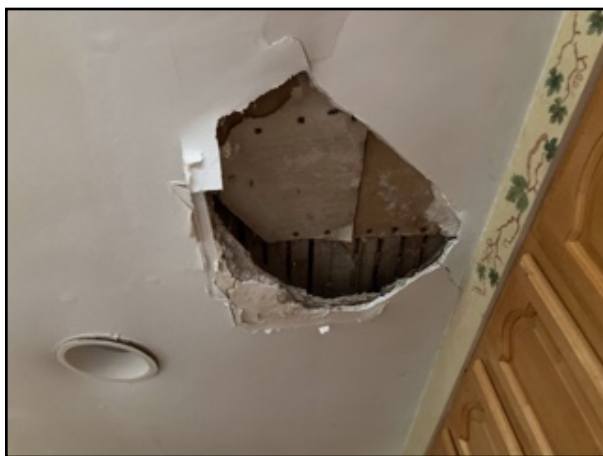
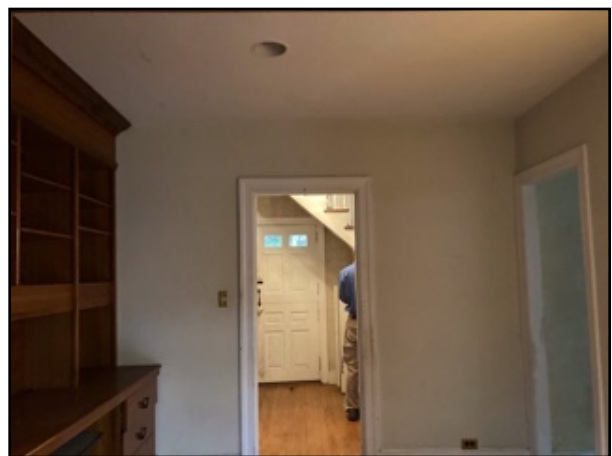
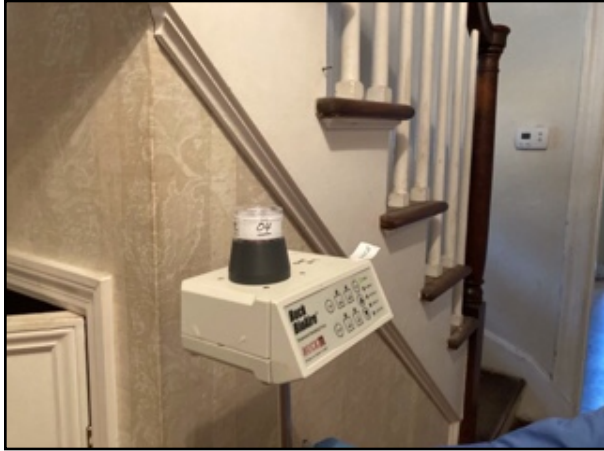
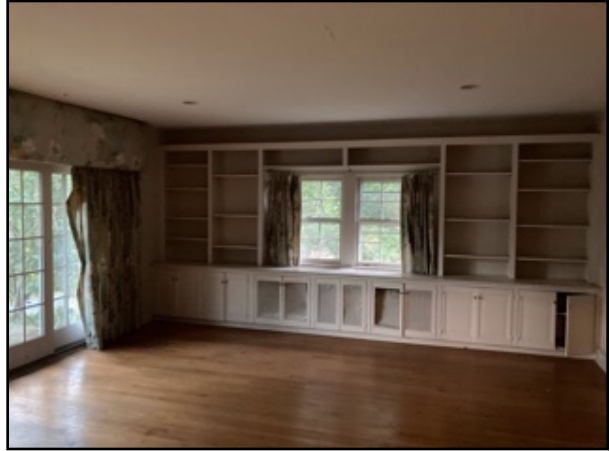
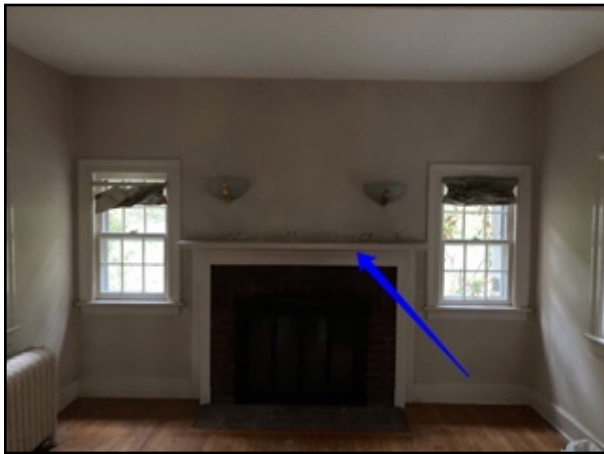
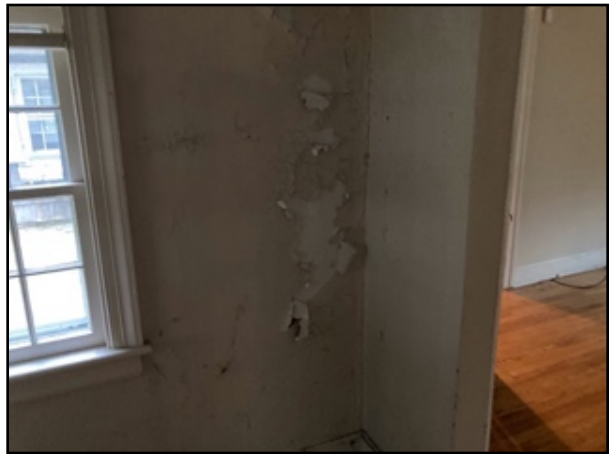
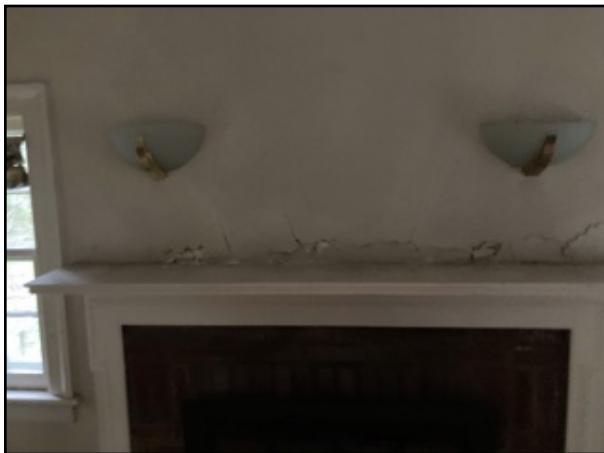
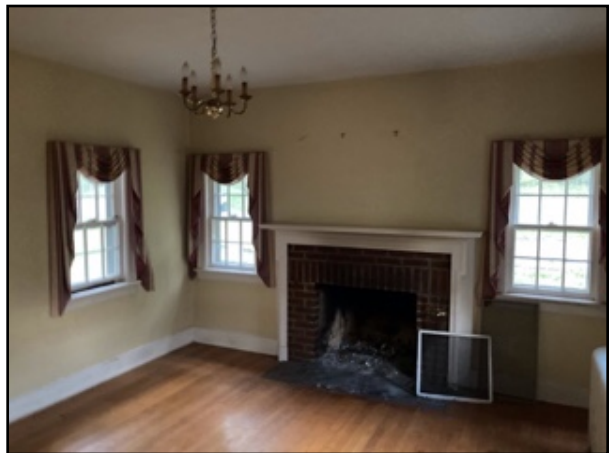
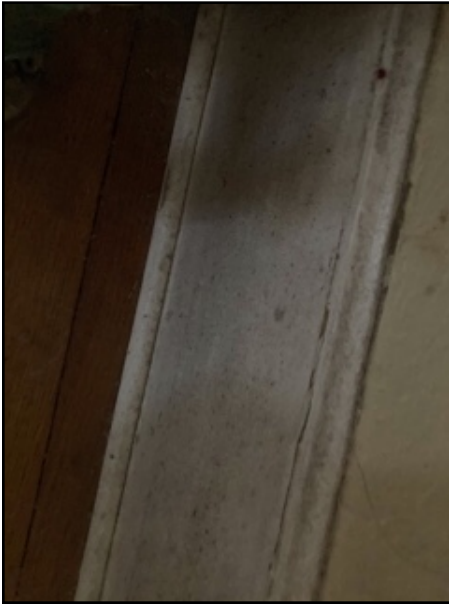
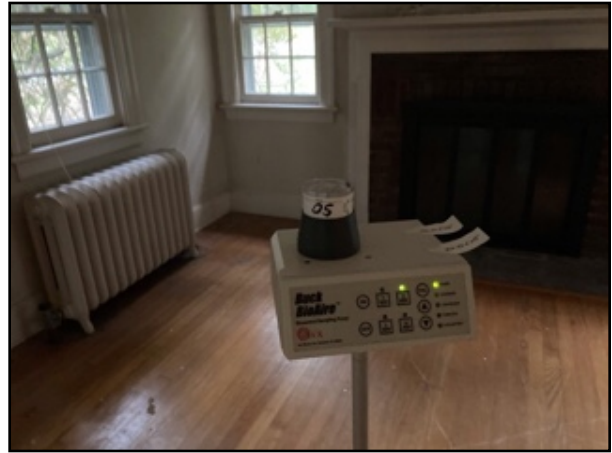
Upon inspection a visual inspection concluded that mold was visible in some areas of the main level. Some concerns were found visually of moisture on the plaster ceiling in kitchen and both fireplace mantels. A mold like substance was also found on various base moldings throughout this level. Inferred camera and moisture readings indicated normal levels of moisture for a plaster ceiling and walls. 3 air samples and 2 swab samples were taken for mold contamination. Recommend 1) Have fireplaces inspected by a licensed contractor 2) Remediation in the affected area as described in the following Remediation Section

B. Main level

- Remove ceiling (plaster, drywall, wood strips, gypsum) in the kitchen and East living room where water intrusion is visible. The ceiling should be opened at least 5x5 sq ft. If mold is visible continue to remove until a clean margin is found.

- Follow cleaning methods below.

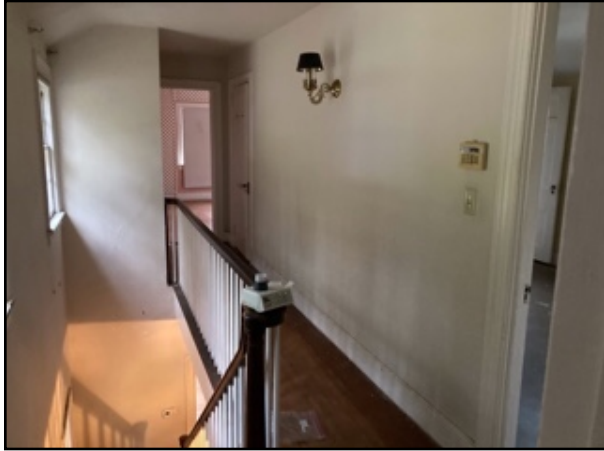
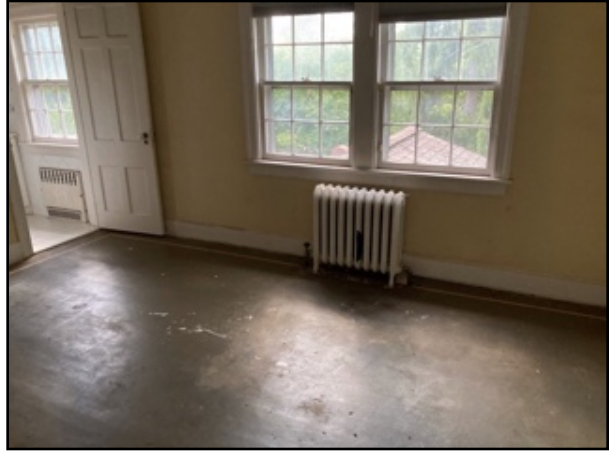
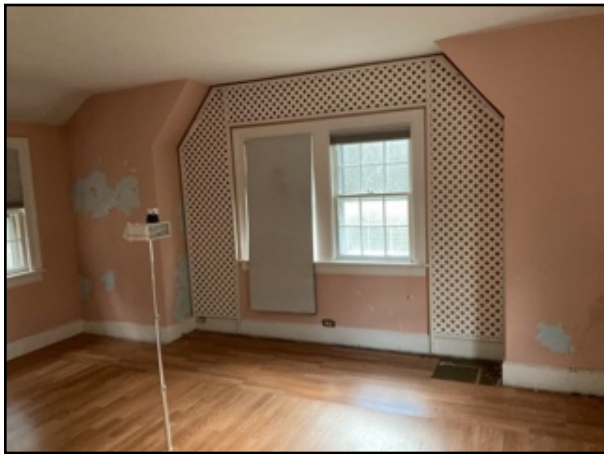
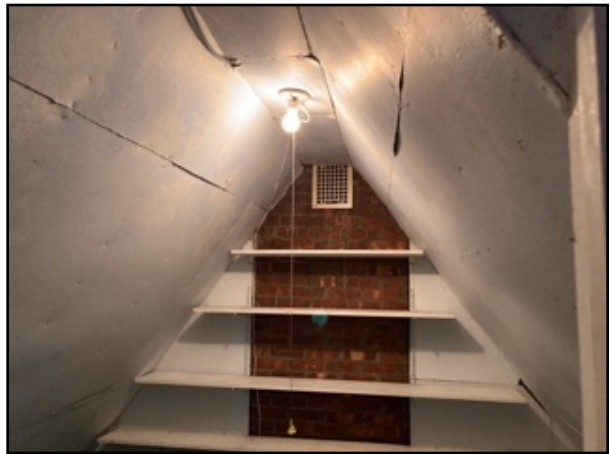
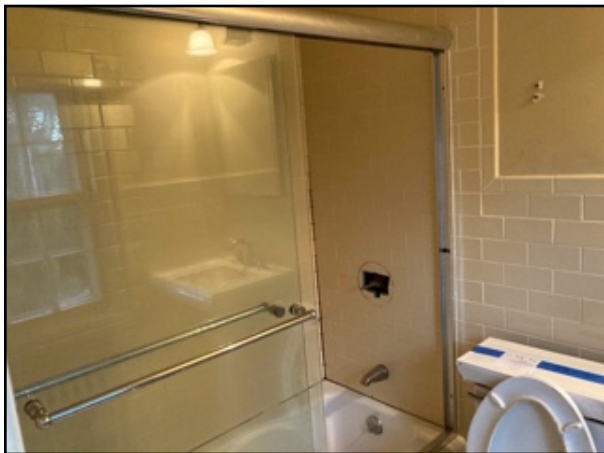
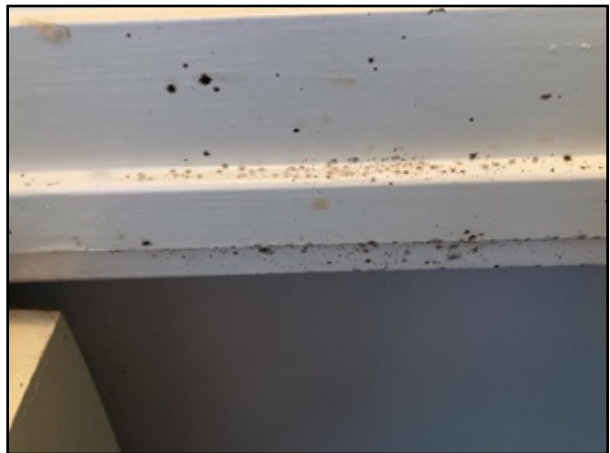
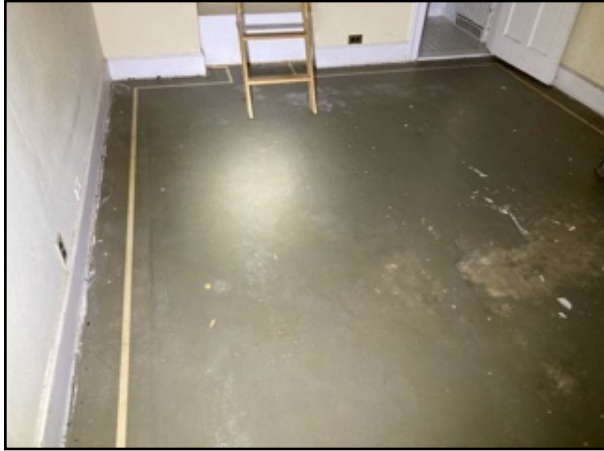
Upon inspection a visual inspection concluded that mold was visible in some areas of the 2nd level. A mold like substance was found on various base moldings throughout this level as well as door trims. Inferred camera and moisture readings indicated normal levels of moisture for a plaster ceiling and walls. 3 air samples and 2 swab samples were taken for mold contamination. Recommend 1) Remediation in the affected area as described in the following Remediation Section

C. 2nd level

- Remove all carpeting/upholstery. Follow cleaning methods below

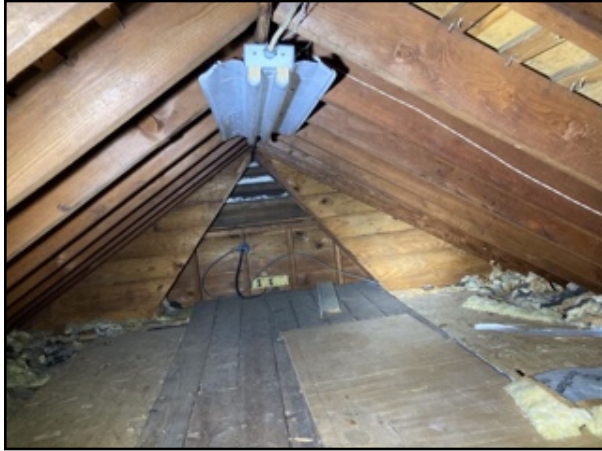
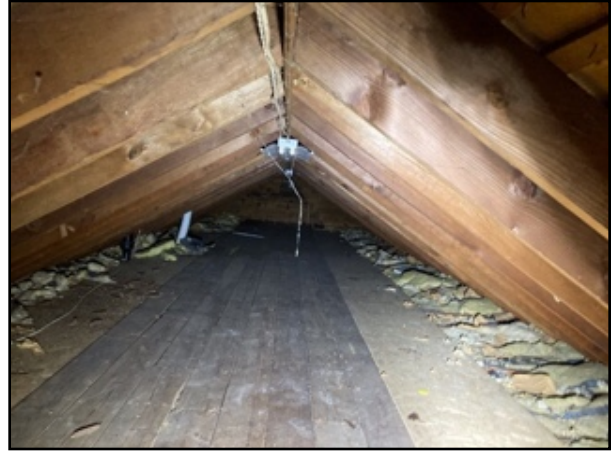
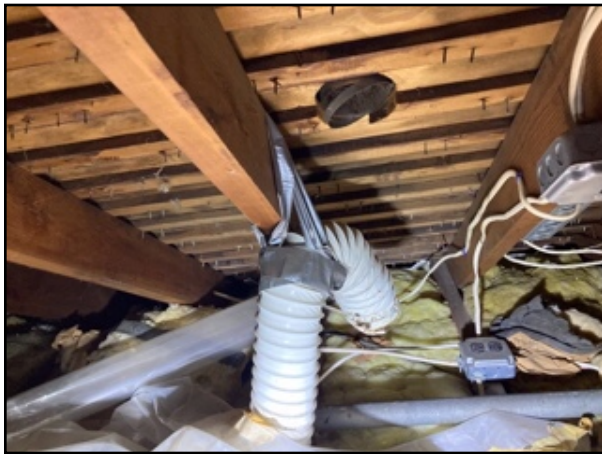
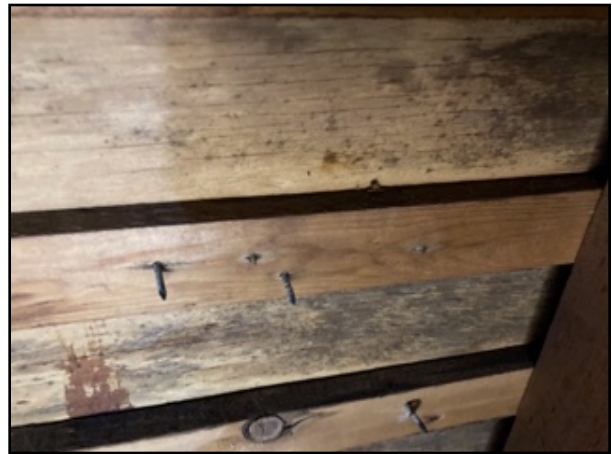
Upon inspection a visual inspection concluded that a mold like substance was visible on the ceiling rafters and exposed insulation. Since there is a lack of ventilation and roof is in poor condition poor air quality/heightened mold spores are common. Ceiling exhaust vent is also dislodged and can cause warm damp air to enter into this space. 2 swabs were taken for mold contamination. Recommend 1) Install a vent to control humidity and add ventilation. 2) Fix bathroom vent 3) Remediation in the affected area as described in the following Remediation Section

D. Attic (Mold Remediation Required)

- Remove all exposed insulation. Follow cleaning methods below.
