BNF Consulting, Inc.

Mold Survey Report

ADDRESS

Inspected on Tue, Aug 17 2021 at 10:00 AM

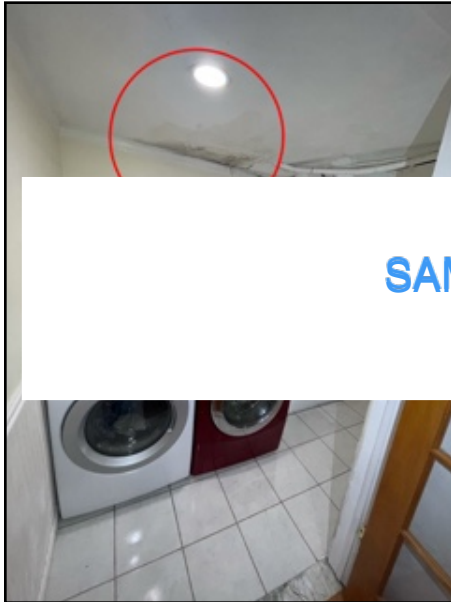
Comment 3:
Location #2 - Laundry Area

Upon examination of the Laundry Area of the property, BNF Consulting observed an active leak within a pipe in the ceiling cavity of the laundry hallway. Additionally, visible surface mold growth was observed along the cavity of the cabinetry. BNF recommends to remove a 2ft by 2ft area around the saturated drywall ceiling and to remove the cabinetry near the washer/dryer. Next proceed with Standard HEPA Cleaning Protocol (HEPA VAC, Anti-Microbial Wipe, HEPA VAC) with encapsulation of the studs and joists as necessary.

3b. LAUNDRY AREA: Remove a 2ft by 2ft area around the two heavily saturated areas along drywall ceiling and to remove the cabinet near the washer/dryer. Next proceed with Standard HEPA Cleaning Protocol with encapsulation of the studs and joists as necessary.

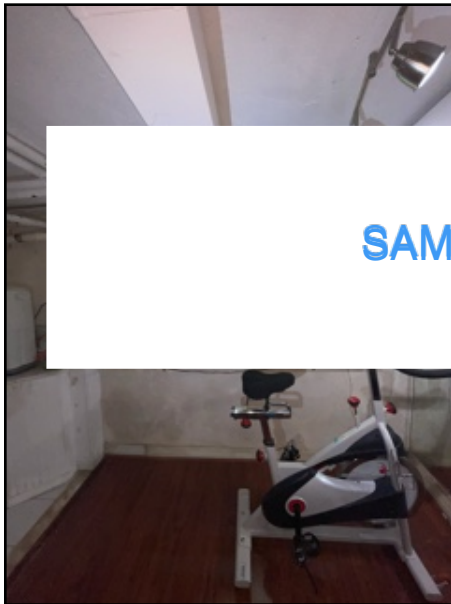
Comment 4:
Location #3 - Gym

Upon examination of the Gym, BNF Consulting observed visible surface mold growth along the surface of the foundation walls, ceiling and on the weights. Additionally, moisture readings upon contact revealed that about 2 feet of the drywall corner near the storage room door was saturated. BNF Consulting recommends remove the saturated portion of drywall then to remediate this location by Standard HEPA Cleaning Protocol (HEPA VAC, Anti-Microbial Wipe, HEPA VAC) with encapsulation of the wall as necessary.

3c. GYM/UTILITY ROOM: Remove the saturated portion of drywall then to remediate this location by Standard HEPA Cleaning Protocol (see floor plan)

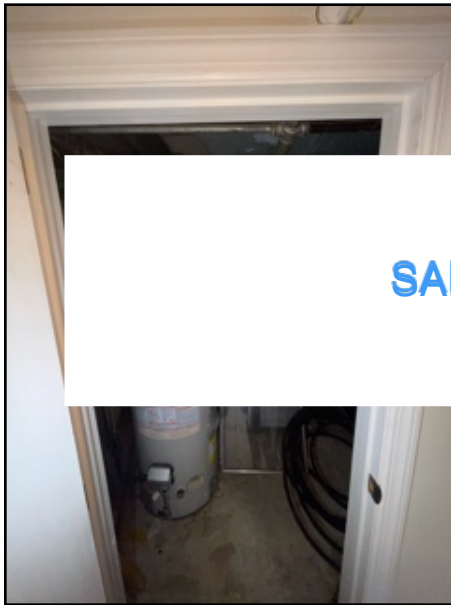
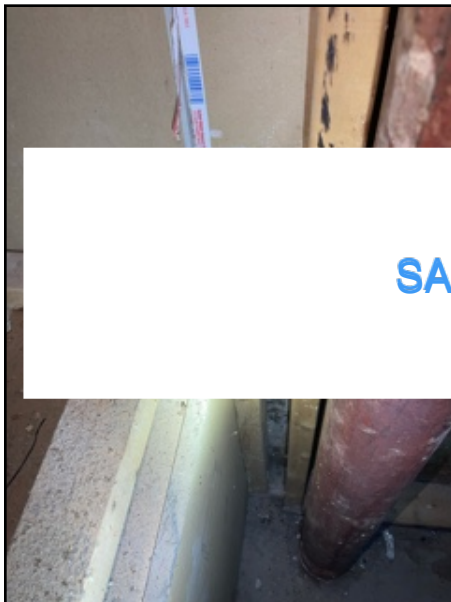
Comment 5:
Location #4 - Utility Room

Upon examination of the Utility Room of the subject property, BNF Consulting observed a slight presence of visible mold growth along the back side of the sheet rock (adjacent to the playroom). BNF recommends to remove the contaminated portion of drywall then to proceed with Standard HEPA Cleaning Protocol (HEPA VAC, Anti-Microbial Wipe, HEPA VAC).

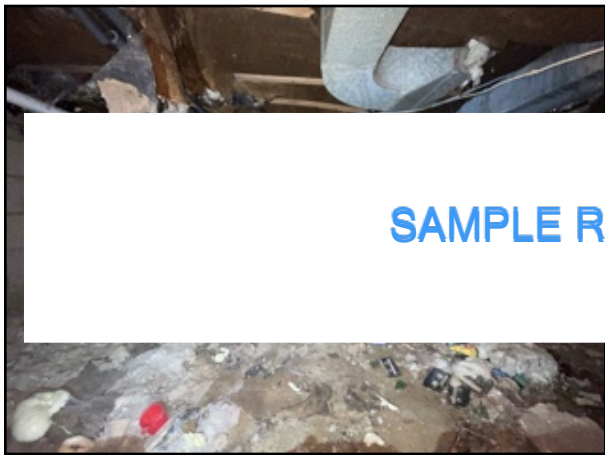
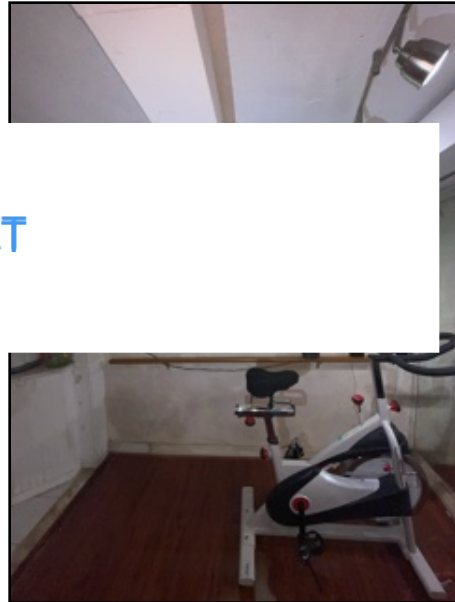
Comment 6:
Location #5 - Crawlspace

Upon examination of the Crawlspace of the property, BNF Consulting observed a very elevated relative humidity as well as saturated and deteriorated insulation. BNF recommends to remove all insulation, then to proceed with Standard HEPA Cleaning Protocol and encapsulation of the joists as necessary.

3d. CRAWLSPACE: Remove all insulation, then proceed with Standard HEPA Cleaning Protocol.
